Tourer Damp Report

Customer Name: **Walter Clark**
Address: **38 Rockwood Drive,**
Town/City: **SKIPTON**
Postcode: **BD23 1UW**
Vehicle Make and Model: **STERLING EUROPA 460**
CRIS/VIN Number: **SGDS006 SW60828782**
Job Reference: **-NVdj-P5k2tL_FuGhNeO**

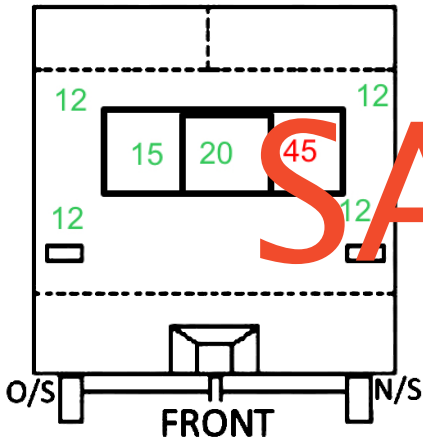
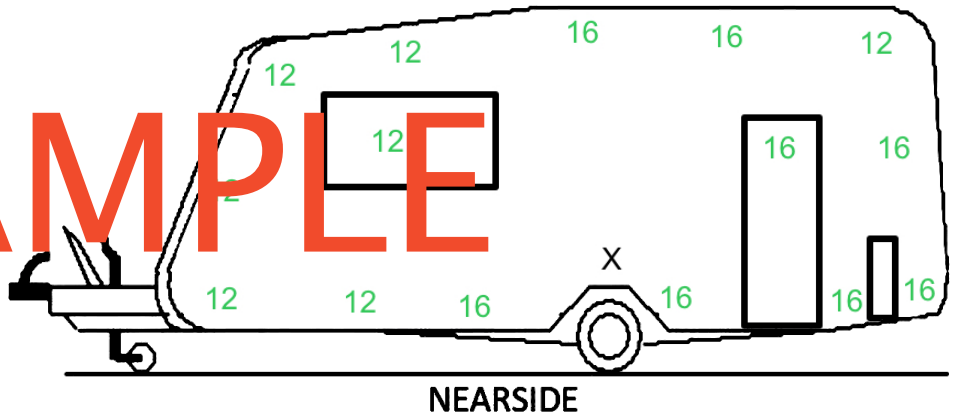
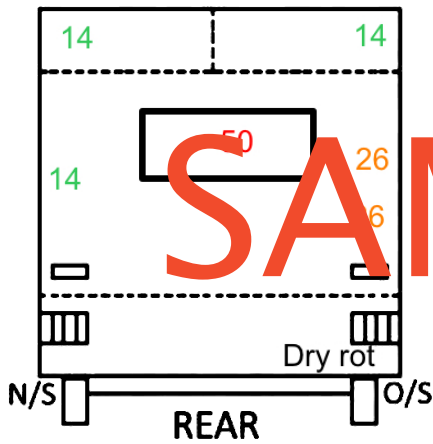
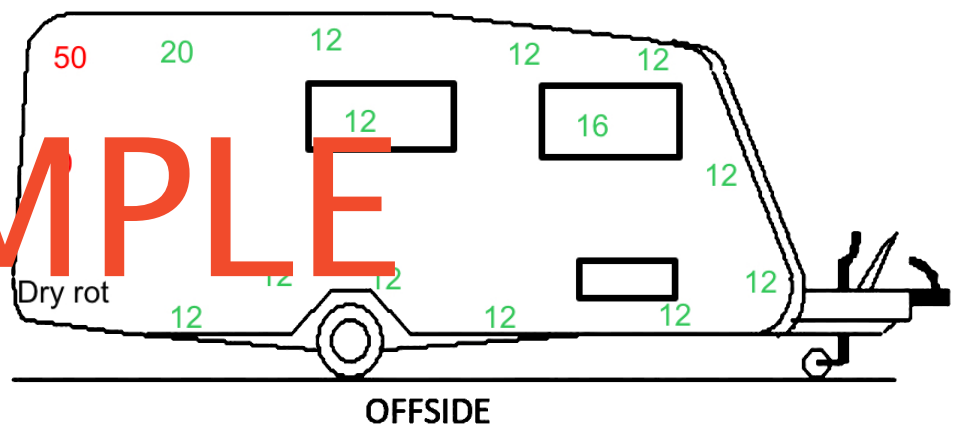
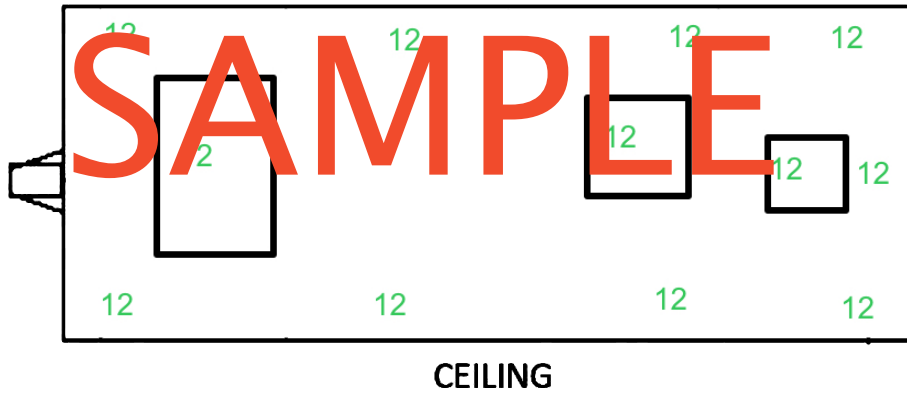
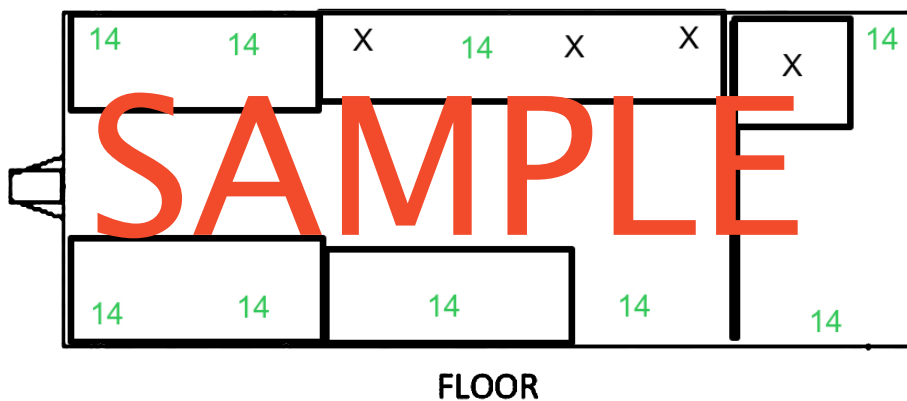
Tourer Damp Report

High damp readings front window
High damp readings rear window and offside rear
